Grade Church
Ruan Minor, Cornwall

Bat and Barn Owl Surveys
and Bat Mitigation Statement

Ref:
BE443

Date:
1st July 2019

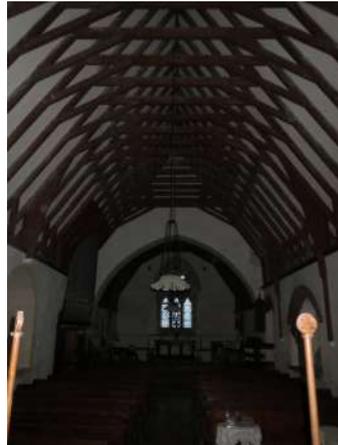
Photograph 4 Inside of the church.

During the visual survey carried out on 6th June 2019 the only location at the church where evidence of bats was found was a small number (<10) of bat droppings on the floor of the vestry/organ room. Whilst it was possible to climb the tower stairs, it was not possible to enter the floors of the tower as these were deemed unsafe. It is possible that some evidence of bats was missed in the tower.

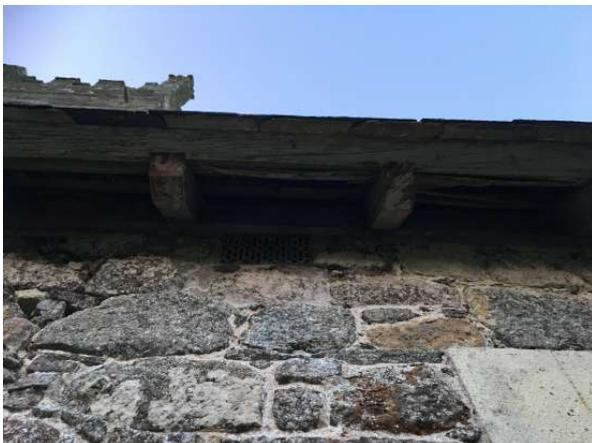
Photograph 5 Potential bat accesses at the eaves

A search around the outside of the church identified many potential bat access points. It is possible that bats could gain entry via the many gaps at the overhanging eaves (see Photograph 5) or at the junctions between the stonewalls and the slates on the roof slopes (see photograph 6). There were many areas where bats could roost unseen. There are louvers on the tower. It is not known whether these provide potential access for bats or whether they have a wire mesh behind. On the 20th June 2019 a single bat dropping was also noted on the alter.

North elevation wall plate/eaves access – along the north elevation of the church gaps (at least 6 along this elevation) will be left on the top of the stonework to allow bats to land on the stone wall and crawl onto the wall top as shown on Photograph 8. These gaps will be at least 50mm x 25mm and their locations will be indicated by the ecologist to the site manager.

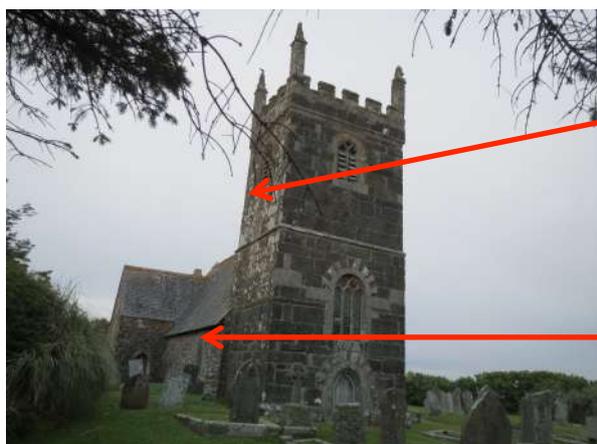
Photograph 7 Points of bat emergence

6th June 2019 – Four common pipistrelle bats emerged from the church. Two bats were clearly seen to emerge from the north elevation at the eaves (see Photograph 7). The other two were seen to drop from the tower on the east elevation; it is presumed that they emerged from the louvers (the exact point of emergence was not seen).

20th June 2019 – Two common pipistrelle bats emerged from the church. One was seen to emerge from the north elevation at the eaves. The other dropped from the tower on the east elevation; it is presumed that this emerged from the louvers, the exact point of emergence was not seen.

Two common pipistrelle bats dropped from the tower on 6.6.19 and one on 20.6.09

Two common pipistrelle bats emerged from the eaves on 6.6.19 and one on 20.6.19

The surveys indicate that Grade Church is used as a day roost by up to four common pipistrelle bats. Two bats roost near the wall tops at the eaves on the north elevation as indicated on Photograph 7. The other two bats appear to roost within the tower and their access point being the louver windows.

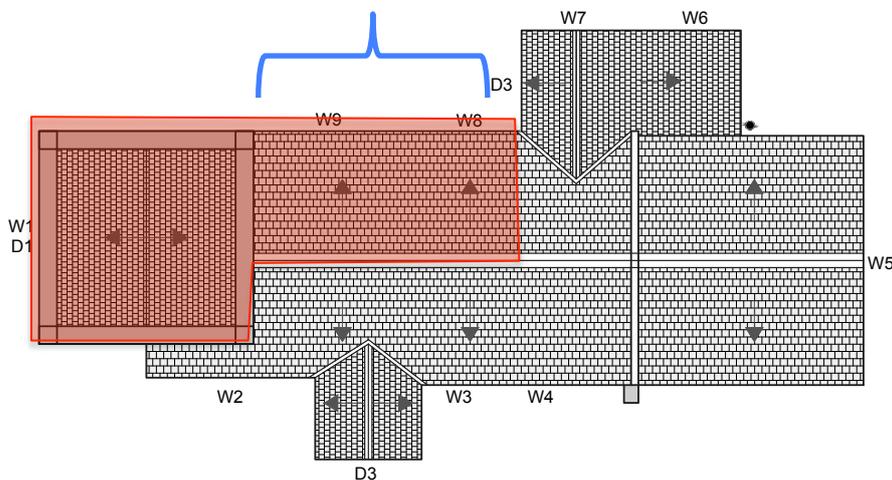
Figure 1. Grade church roof plan showing bat mitigation summary

Leave at least six 50mm x 25mm gaps on the top of the stonework along the north elevation of the church to allow bats to land on the stone wall and crawl onto the wall top

Through consultation with the architect this mitigation plan has been designed to minimise impacts on bats and maintain the population in favourable conservation status. Works affecting bats will be carried out at a time of year when bats are active and able to move to safety. All works affecting bats will be carried out under an ecological watching brief. The current bat accesses will be retained. Mitigation measures are summarised on Figure 1.

- Works will only commence once a bat license has been obtained.
- Works within the red shaded area will commence between mid-March and Mid-November when temperatures are above 10C and will be carried out under ecological supervision.
- If membranes are used they must be traditional bitumen felt.
- Bat access to retained at louvered windows on tower by retaining 50mm x 25mm gaps between the louver openings and the surrounding stone edging.
